Responsible Retrofit Series

Case Study

Whole House Retrofit Ton Pentre

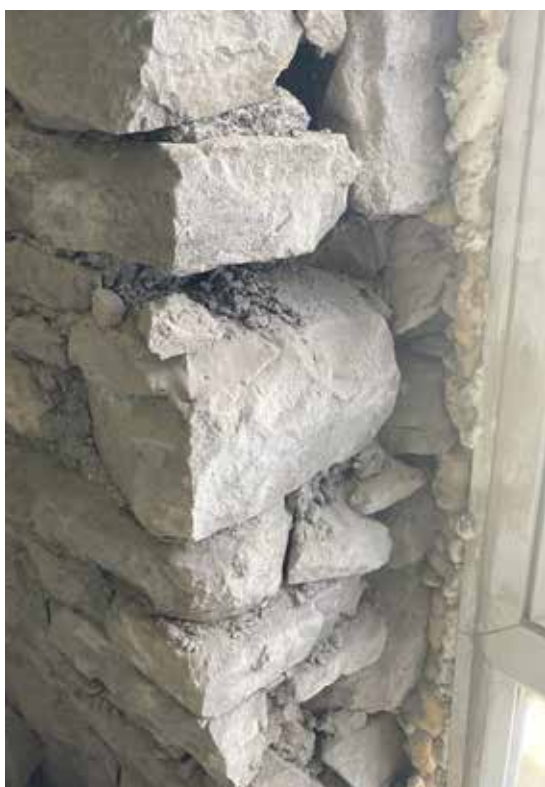
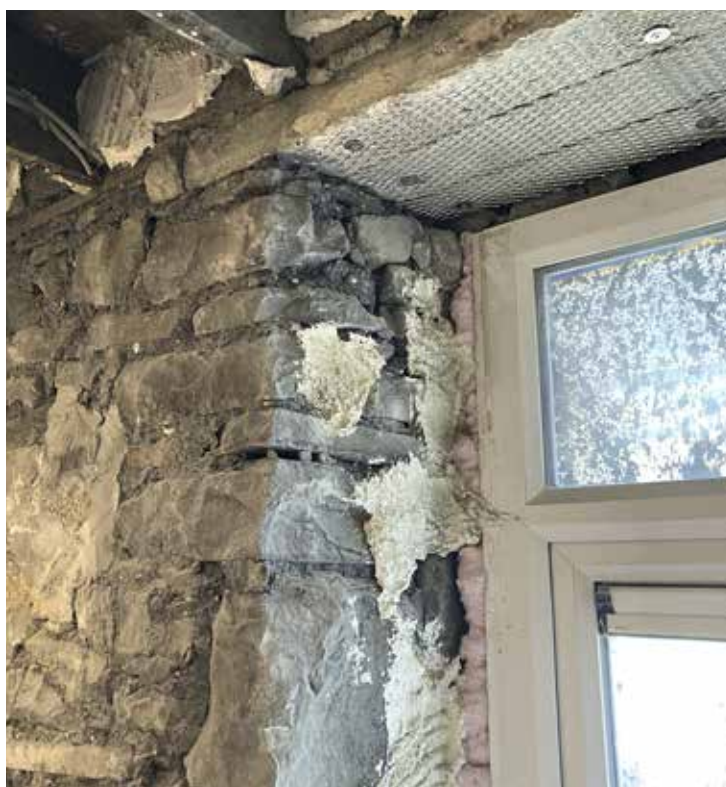
Reveals exposed prior to repair and IWI

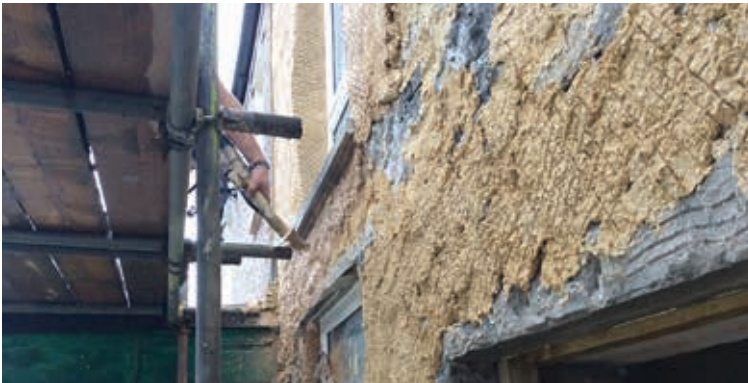
External wall dubbed out by harling prior to pumped application of render
©Peter Draper

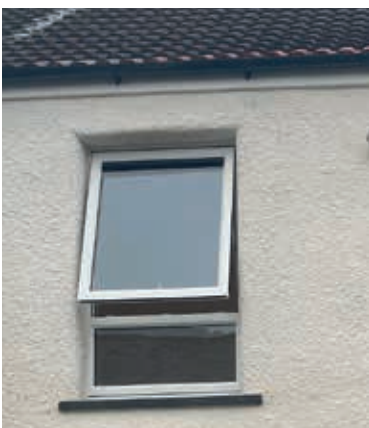
Finished render with limewash sacrificial layer ©Peter Draper

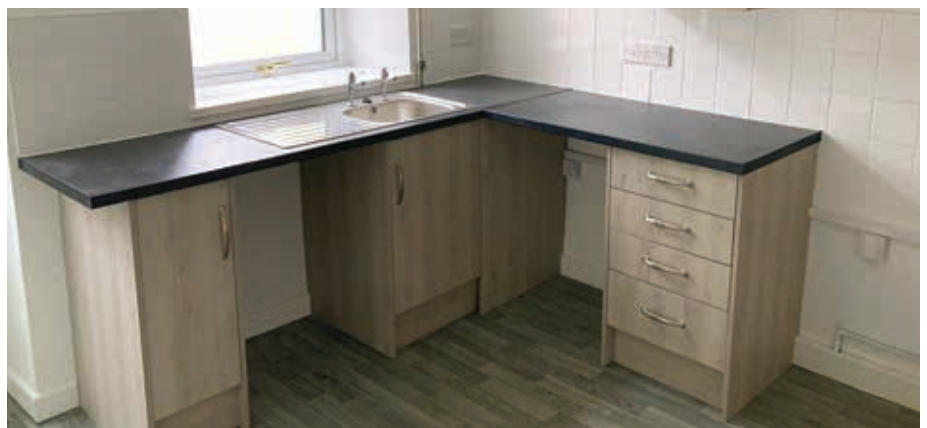
Finished kitchen units on external and party walls
©Peter Draper

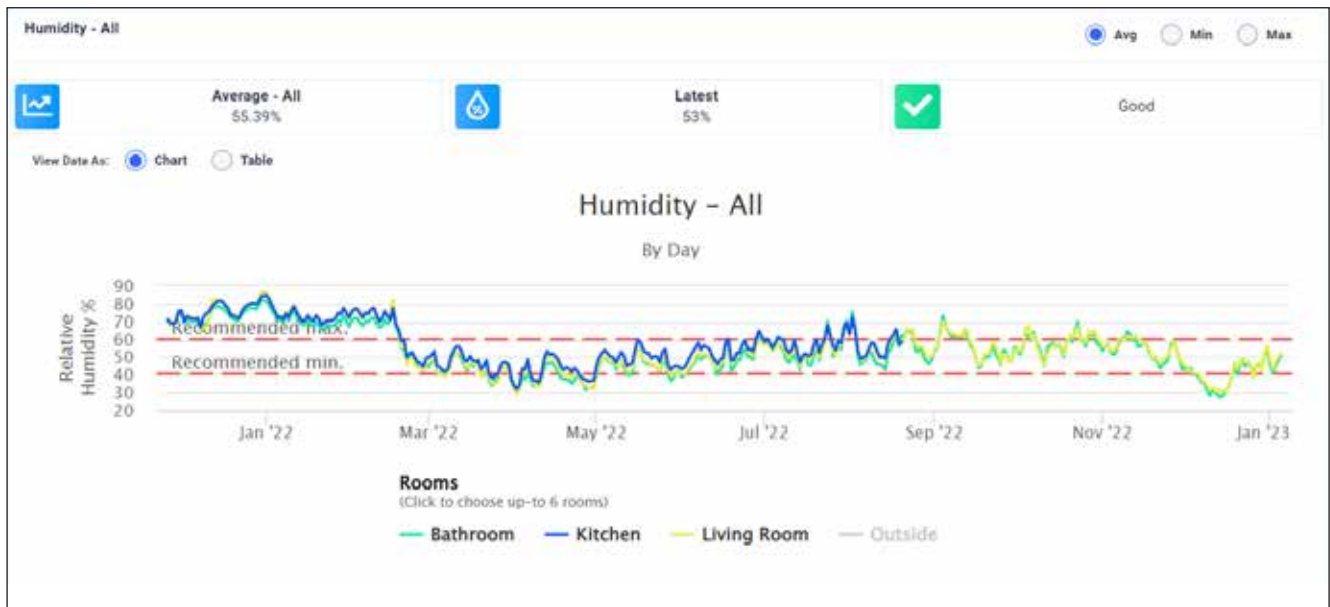
Monitoring shows IAQ metrics within 'ideal/safe' bounds with RH between 40-60% in all rooms.

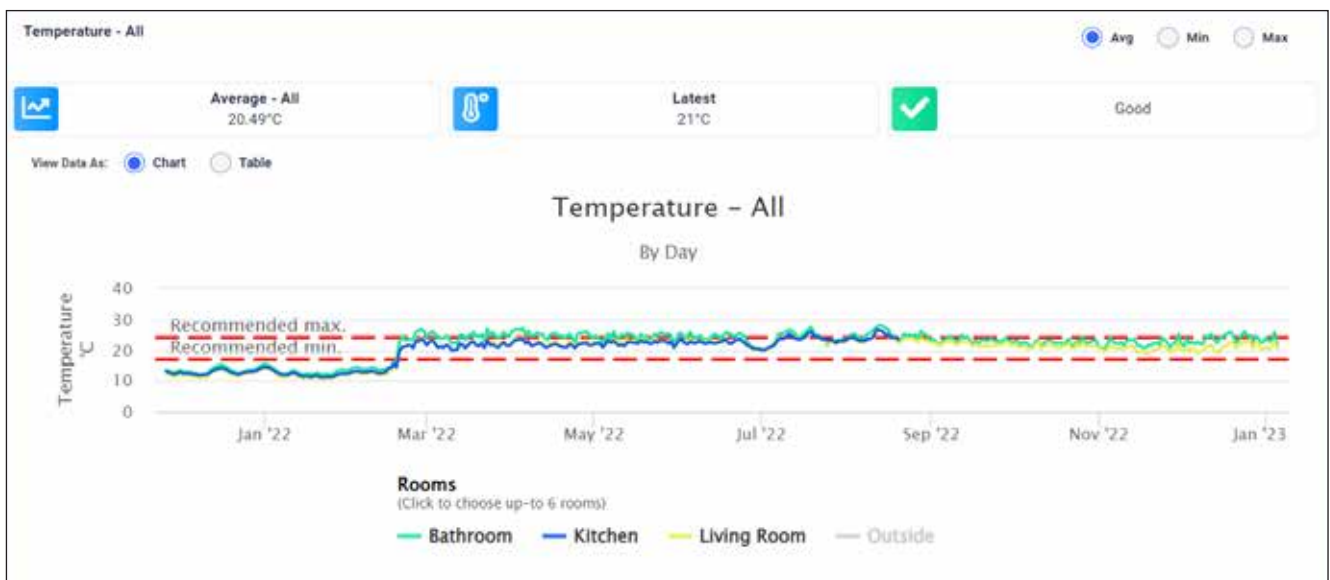
Monitoring shows IAQ metrics within 'ideal/safe' bounds with temperatures between 18 and 24° C in all rooms.

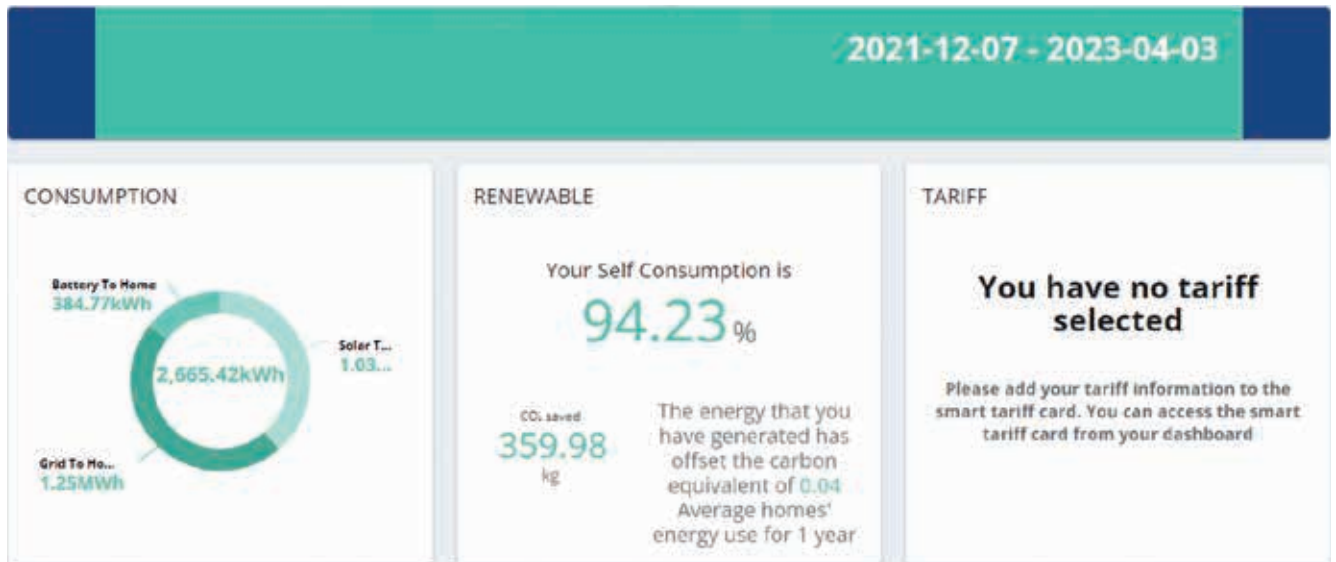
Inbuilt PV and battery monitoring shows a self-consumption rate of over 94%. (ie, electricity produced and used by the tenant, either directly whilst producing, or via stored energy via the battery.) The consumption figures also show that of the 2,665 kWh used to date, 1,415 kWh was self-generated. This represents a saving of over 50% on energy costs for the tenant.
