## STBA TEIF Project Update - Autumn 2021

The BEIS funded TEIF project run by the STBA has entered and interesting moment. We are working with Rhondda Housing Association (RHA) on two properties in the SW Valleys. Both are voids and this has allowed us to be slightly more ambitious than we were originally allowed with tenanted properties with Melin Homes.

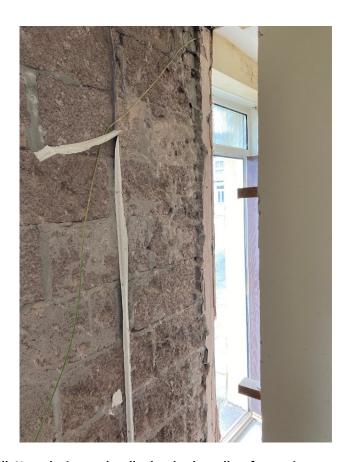
To our surprise the front wall of the property turned out to be a block cavity! So the planned use of the aerogel plaster and lime render to the west facing front wall (along with the associated interstitial hydrothermal monitoring equipment) had to be changed to the rear east facing wall. The front wall therefore had the Diathonite IWI applied and the existing external cement render was left intact so as not to damage the blocks.

Blockwork to the front wall. Note the internal wall taken back to allow for continuous application of the IWI.

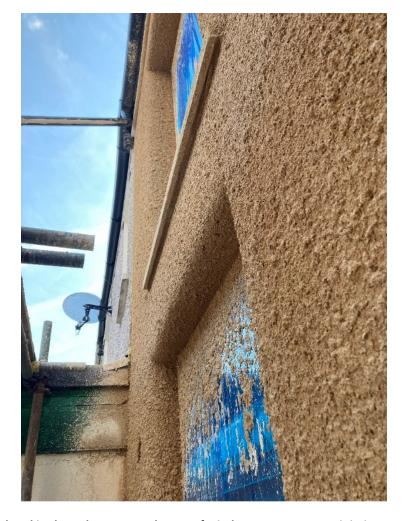
Lime rendering completed in three days. Note: The use of window protectors to minimise potential damage and reduce cleaning times during the application process; The Tyrolian finish was decided on as it gives a higher surface area for any moisture to evaporate from; Window reveals shaped to give a rounded edge;

Drip detail retained on window sill; Scaffold set back to provide room for spray equipment.

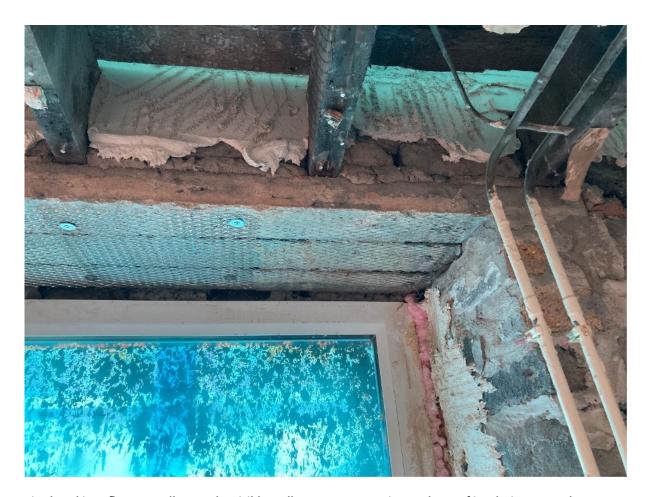
IWI is placed interfloor as well as on the visible walls to create a continuous layer of insulation. Note the use of mesh on the header and some dubbing out around the reveal.

The removal of the cement and gypsum based internal plaster created massive gaps around the windows and door, so much so that the door had to be replaced due to the 7cm gap between wall and frame. Original splayed windows had been squared off (there were chucks of cement around 8-10cm deep removed) and doors and windows gradually become smaller over time due to fitting practices and the gaps just get filled up with cement. So these areas (which are most prone to thermal bridging) actually ended up with some of the thickest layers of IWI. The IWI could be applied up to around 10cm deep in one coat, but we were aiming for around 2.5-3cm to reach the 0.7U value agreed.

We agreed to use a plastic mesh across the wall, although one wasn't needed by the specification, as it was a kitchen environment in a rented house. This was pressed into the first 15mm coat with a 10-15mm second coat. The IWI felt spongy at first but this should slowly become hard. The final coat was a conventional lime plaster at 5mm. This will then be painted using a breathable and scrubbable paint.

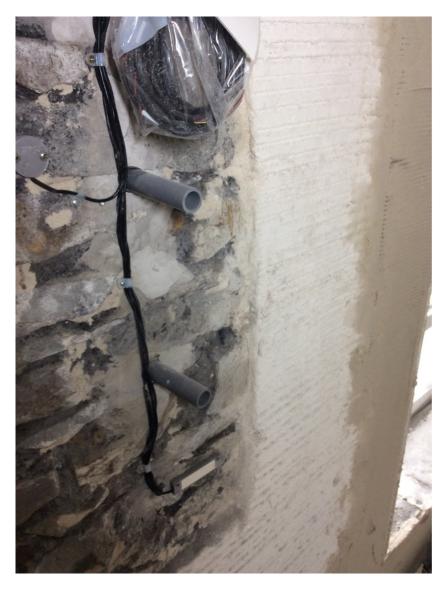
Monitoring by Archimetrics in situ ready to be plastered and rendered over.
